**DEPARTMENT OF TRANSPORTATION****DIVISION OF ENGINEERING SERVICES**

Office of Structural Materials

Quality Assurance and Source Inspection

Contract #: 04-0120F4Cty: SF/ALA Rte: 80 PM: 13.2/13.9File #: 69.15**SOURCE INSPECTION REPORT****Resident Engineer:**Pursell, Gary**Address:** 333 Burma Road**City:** Oakland, CA 94607**Report No:** SIR-002445**Date Inspected:** 02-Jul-2010**Project Name:** SAS Superstructure**OSM Arrival Time:** 700**Prime Contractor:** American Bridge/Fluor Enterprises, a JV**OSM Departure Time:** 1900**Contractor:** Zhenhua Port Machinery Company, Ltd (ZPMC), Changxing Island **Location:** Shanghai, China**Quality Control Contact:** Mr. Don Walton**Quality Control Present:** Yes No**Material transfer:** Yes No N/A**Sampled Items:** Yes No N/A**Stock Transfer:** Yes No N/A**OK to Cut:** Yes No N/A**Rebar Test Witness:** Yes No N/A**Delayed/Cancelled:** Yes No N/A**Other:** Coating Inspection**Bridge No:** 34-0006**Component:** See Below**Bid Item:** 77, 78, 79**Lot No:** B #204**Summary of Items Observed:**

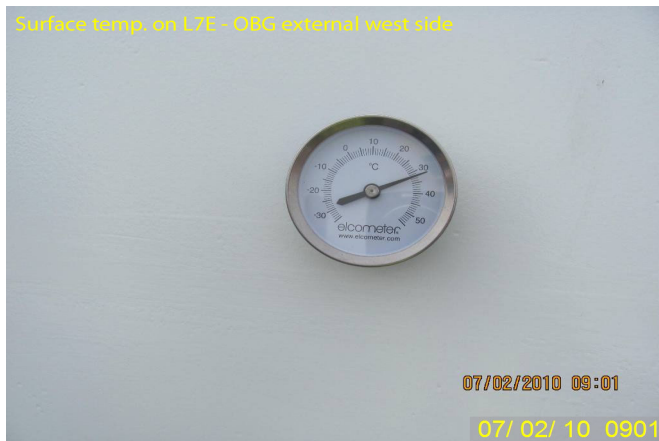
3. An inspection was requested for the OBG internal longitudinal diaphragm damaged areas reblasting L7E, vide inspection request no. 3535. This Caltrans inspector observed, ABF inspector Mr. Sun, Mr. Vince and Mr. David performed the Blasting inspection and accepted the same except areas between PP57 to PP57 as the surface temperature in these areas found to be more than 38 deg. celcius which is not acceptable as per contract documents.

Surface temp. on L7E - OBG external west side

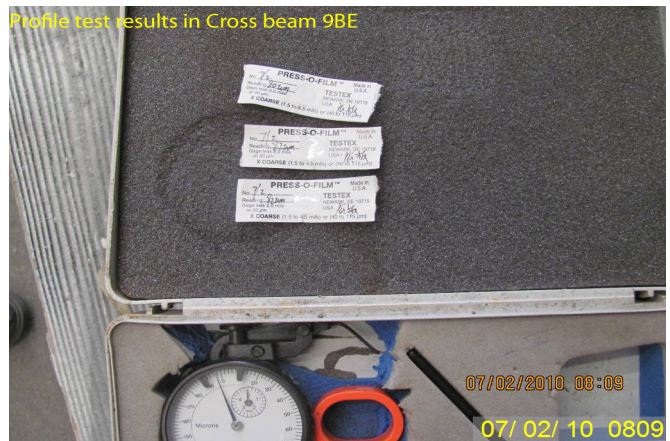
1. An inspection was requested on the OBG Cross beam (9BE) bottom plate external support areas reblasting, vide request no. 3530 at Painting shop 1. This Caltrans inspector observed, ABF inspectors Mr. Sun , and Mr. David performing said inspection check . It was observed that, these surfaces were accepted by ABF Inspectors . The surface profile found to be in the range of 80 to 82 microns. The ambient conditions were monitored and is 5. 1 deg. above dew point and the relative humidity found to be 76.8% which is acceptable as per contract documents. International protective coatings technical service representative Mr. Lou Qian Chuan was found present during the course of this inspection process. (Photograph showing surface profile measured by Coarse grain method and ambient conditions during this inspection is attached)

Profile test results in Cross beam 9BE

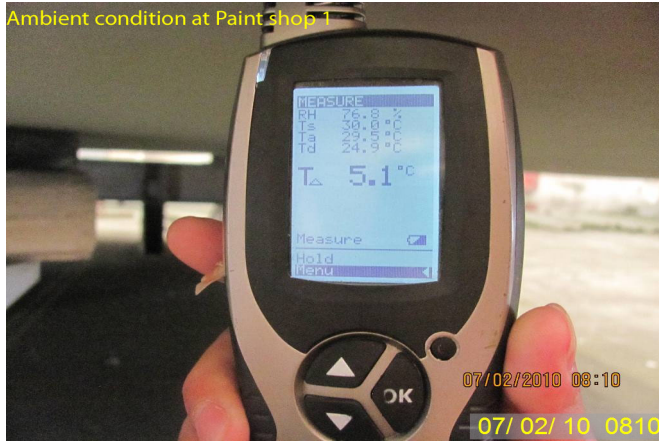
Ambient condition at Paint shop 1
